Manhole Inspection Summary

Manhole # S41AA_049MH

Insp Date: **1/30/09 2:43 PM**

Location Address: **1400 e madison st**

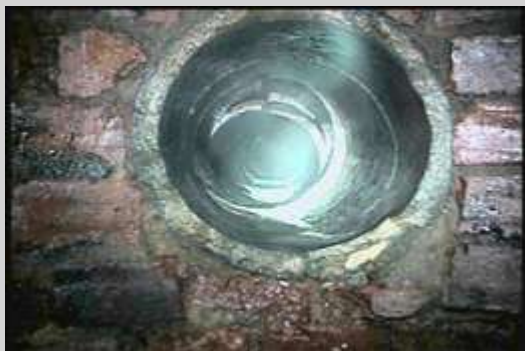
4 O'Clock Inflow

4 in. Circular Gravity Sewer
Pipe In @ 4 O'Clock

Pipe Material: Clay ☐ Pipe Lined

Invert Depth: 8.33 (ft.) Flow Characteristics: Fast

Infiltration: None Pipe Seal Cond: Unknown
